Boiler Safety Bulletin

Calif
Industrial Accident Commission

State of California

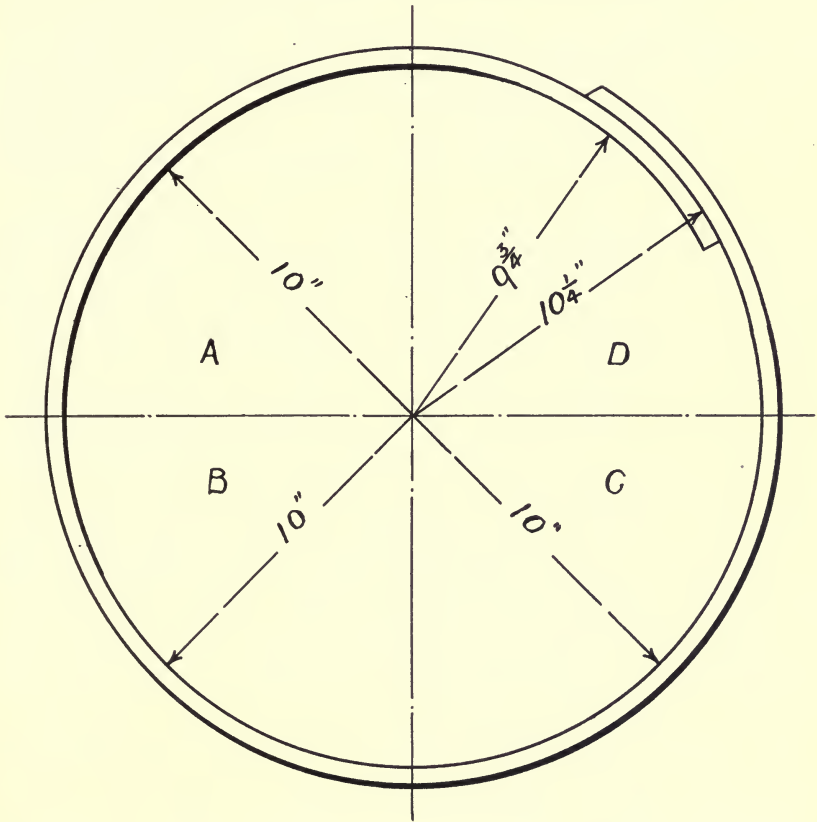
Fig. 1.

To make this point clear, let us refer to Figure One, which represents a cross-section through a shell made of boiler plate one-half inch thick, and rolled to a nominal internal radius of ten inches.

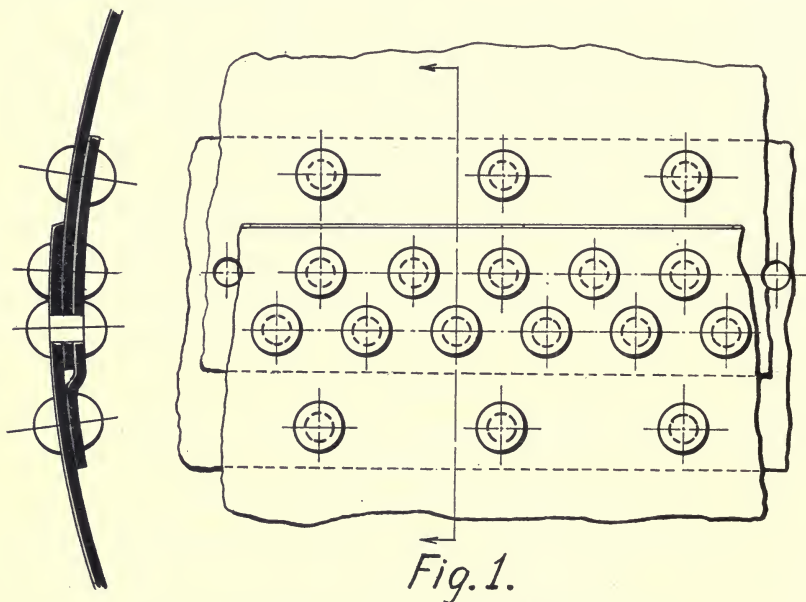
Fig. 1.
Sectional and plan view of lap joint with inside strap applied.

There is nothing new about this type of joint, as it has been known and used for many years, although it has never come into great popularity, owing to the fact that it is a mere subterfuge. In other words, while the application of an inside welt may increase the efficiency of the joint, the joint itself still remains a lap-joint, and as such it may be regarded as still subject to the development of the hidden cracks and to fatigue of

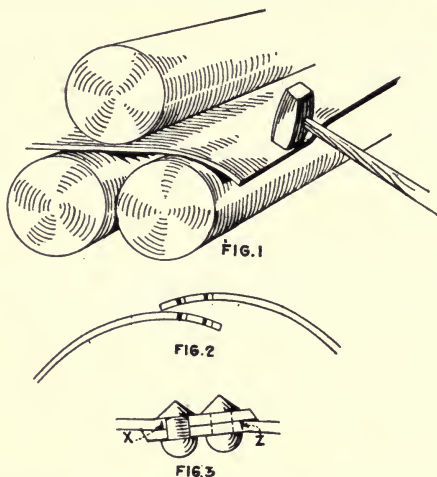
The never-ending effort of the contained pressure to perform the impossible feat of rounding out the irregular surface existing at the lap seams produces the lap-seam crack, for which this joint is notorious. In Fig. 3, x and z indicate the development of such a crack, while Fig. 5

Fig. 1. Forming end of plate over roll.
 Fig. 2. Ends of plate to be sledged to shape.
 Fig. 3. Lap seam stressed to failure.

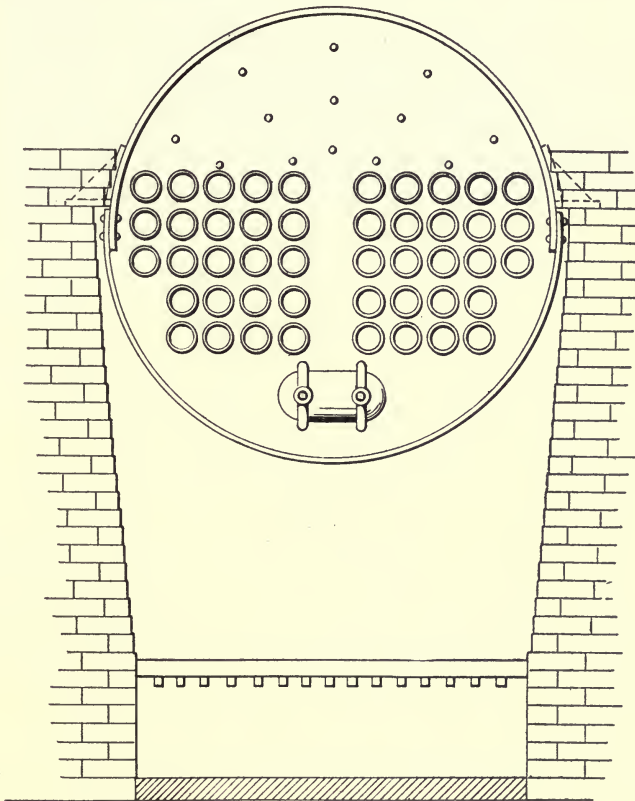
Fig. 4. Seams of single-sheet boiler inaccessible and exposed to furnace heat.

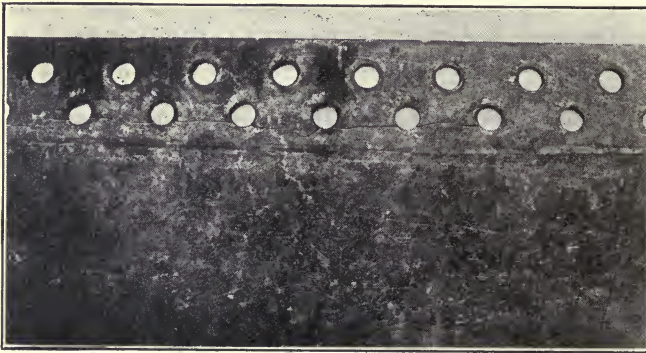
shows a crack that developed in a plate in service. Furthermore, this lack of symmetry renders the plate along the line of greatest stresses susceptible to corrosive action, which would be intensified where there were three pairs of supporting brackets, as was the case with large boilers; and the settling of the furnace walls at the front or rear transferred the load, amounting to one-half the weight of the boiler and contents, onto the center bracket.

Fig. 5. A lap-joint crack.

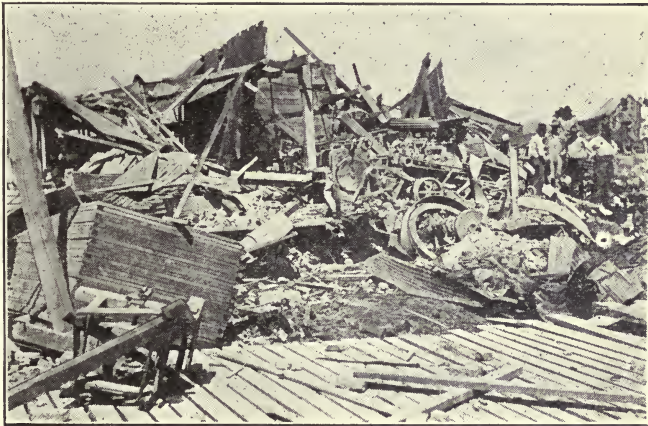
The accompanying photographs, Figs. 6 to 8, illustrate the damage done by the explosion of a single-sheet boiler, which resulted in the death of two workmen, and serious injury of two others, and the total

Fig. 6. Result from the explosion of a single-sheet boiler.

destruction of the plant. Fig. 6 gives a good idea of the general damage to the plant, and Fig. 7 is a close-up view of the boiler tubes and head. The boiler was said to have been about 24 years old, and its builder was unknown, as it had been used elsewhere and had changed owners a number of times. So far as could be learned, the boiler never had been subjected to an examination by anyone qualified to pass judgment in such matters. The double-riveted lap seams extended from the front head to the rear head on each side of the boiler. The means of support consisted of three pairs of castiron brackets resting on the furnace walls, one being between the dome and longitudinal seams, on either side of the boiler. The pressure carried at the time of the explosion was 100 lb., and it was probable the builder sold the boiler when new with the customary guarantee of that pressure, which would be permitted by a factor of safety of 4.

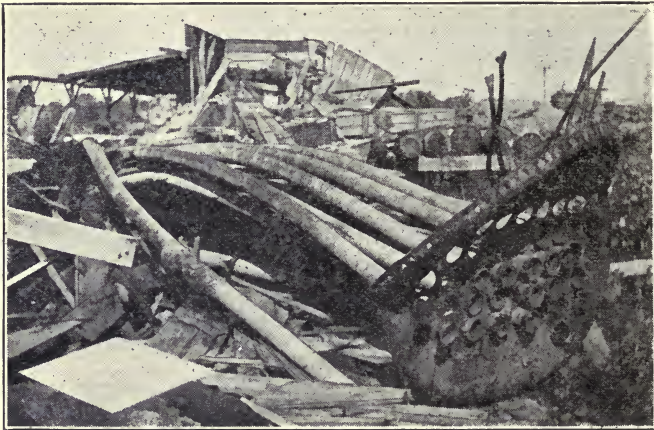
Fig. 7. Close-up view of boiler tubes and head.

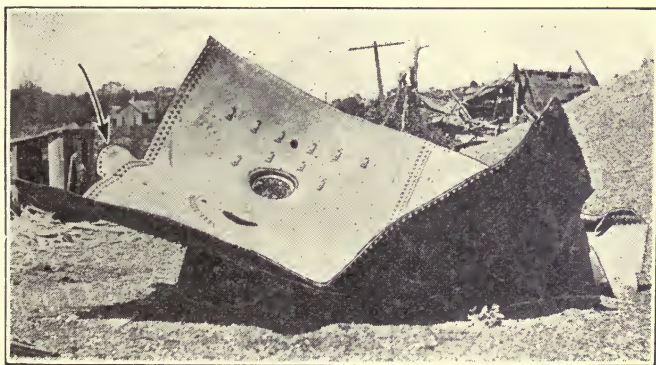
indicated by the arrow in Fig. 8, apparently without giving thought to the cause of the difficulty, but riveting the patch at the boiler seam, and using patch bolts for securing the new seam. The boiler was continued in operation without further trouble until about a week before the explosion, when seam leakage was again observed. The mill superintendent and an employee are said to have drilled and threaded for $\frac{3}{4}$ -inch capscrews, four holes along the seam where leakage had appeared. A soft patch consisting of a sheet of plow steel and a thin sheet of lead was secured to the boiler by means of capscrews and nuts, and the boiler was again placed in service.

The failure occurred in the sheet forming the lower part of the boiler, on a line coinciding with the edge of the inner lap, just about the same location as in the failure of the Fargo, Tex., boiler, and did not follow nor enter the rivet holes. It extended the entire length of the seam, as is customary with violent failure of this kind. The rivets in the head

Fig. 8. Shell plates blown free of the ends and tubes.

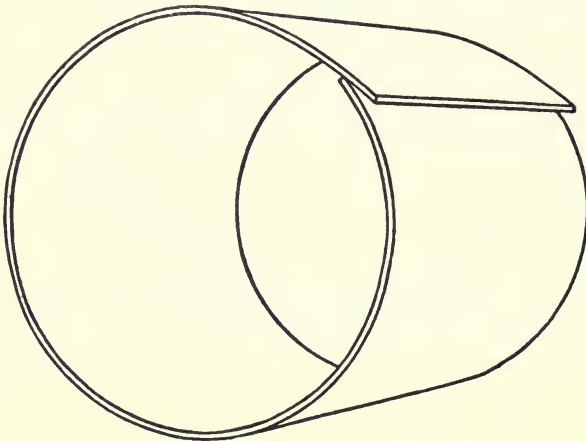
Fig. 1. When plates are rolled to a cylindrical form there is a tendency for plate edges to remain flat as in this case.

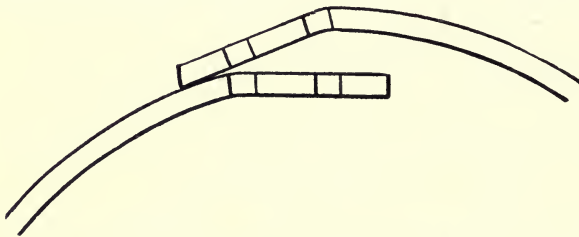
Fig. 2. If bent after punching, plates will bend along a line of rivet holes.

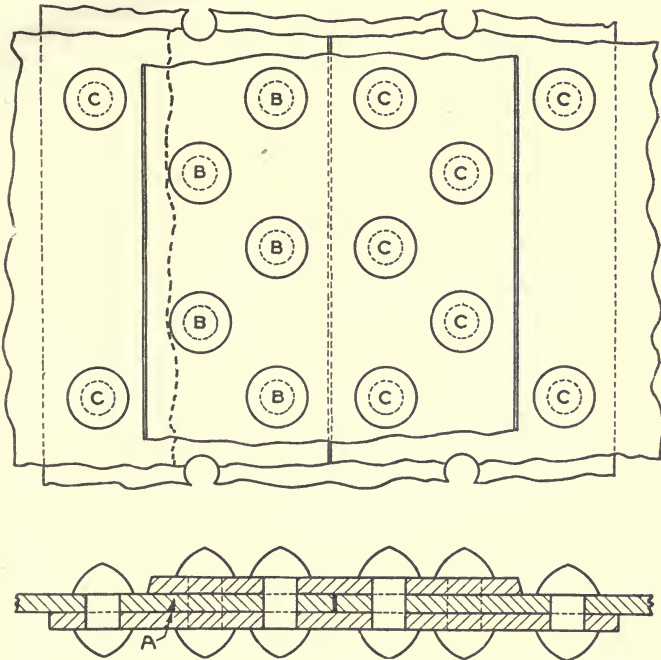
Assuming that a double riveted lap joint has been changed to a triple riveted butt construction, the joint, after placing the butt straps and riveting, would appear as shown in Fig. 5 with the rivet holes of the original lap joint at *B* and the new holes at *C*. If a defect existed in the

plate as shown at *A* the joint would be very faulty. Assuming the original joint as having the rivet holes spaced $3\frac{1}{4}$ inches and the additional holes spaced $6\frac{1}{2}$ inches, if the plate material were defective or contained a lap crack as shown, the failure of the joint would require only the shearing of the rivets in long pitch, or $6\frac{1}{2}$ inches, and the failure of the defective plate.

Fig. 5. Double riveted lap joint changed to triple riveted butt strap type.

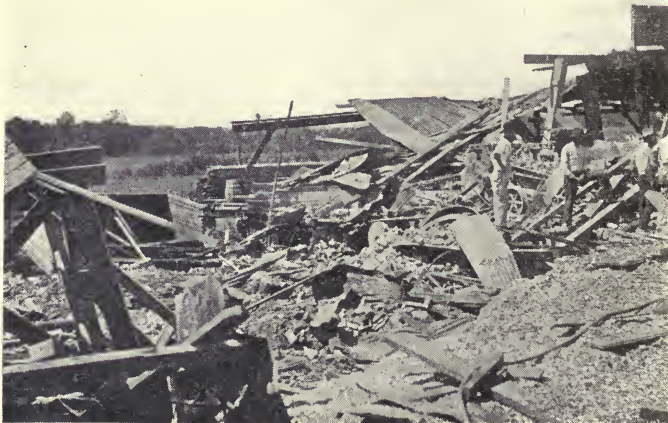
Fig. 1. Result of boiler explosion in planing mill, Antlers, Okla.

At 7:30 a.m., September 20, 1920, the town of Antlers, Okla., was shocked by the explosion of a boiler located in a planing mill at that place. The plant was totally wrecked, and two men were killed, while two others were seriously injured. The head of one of the men who were killed was completely severed from the body.

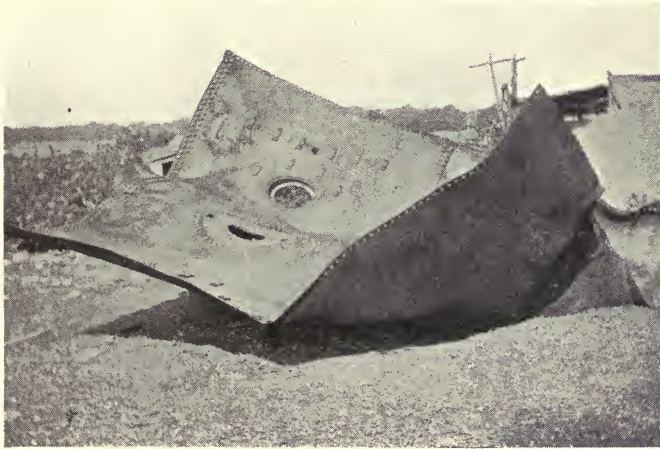
The immediate cause of the explosion was a lap seam crack, which extended from the front head to the rear head of the boiler, along the

Fig. 2. View of shell plates, showing patch and extent of crack.

longitudinal seam, and which no doubt had been years in fully developing. The complete history of the boiler was unknown, but it was said to have been purchased second hand, provided with usual safety appliances, and placed in operation at 100 pounds pressure, which was continued until leakage was observed at the longitudinal seam on the right hand side, when facing the front.

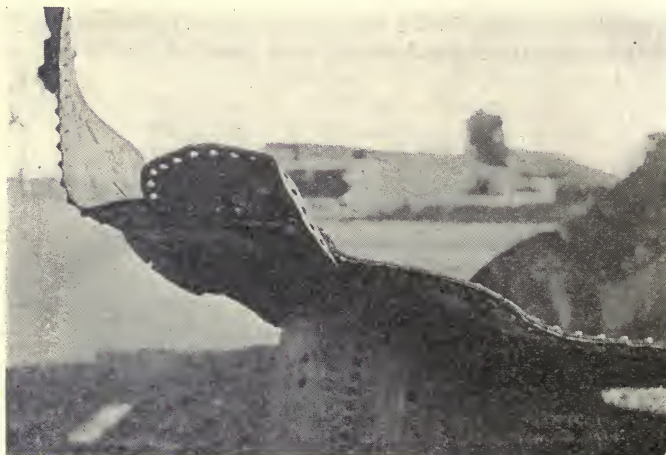
It is possible that the boiler maker who made the riveted patch repair looked with pride upon his work, for the patch was tight, and while its shape could have been improved upon, its workmanship was above the average. It is further probable he had never heard of a lap seam crack. This is a defect thousands of men are seeking daily, in order to prevent just what took place at Antlers, and if this mechanic had been thoroughly posted upon the developments which have taken place in his trade in recent years, the designs which have proven faulty, and the many failures of lap joints, due to the lap joint cracking, he could have prevented the disaster, by refusing to make repairs.

Fig. 3. Close-up view of patch and crack.

extensively with rules controlling boiler repairs. However, there is one requirement which has been almost universally adopted, which prohibits the repairing of a sheet in which a lap seam crack has developed.
